Quality Assurance and Source Inspection

Contract #: 04-0120F4Cty: SF/ALA Rte: 80 PM: 13.2/13.9File #: 69.28**WELDING INSPECTION REPORT****Resident Engineer:**Siegenthaler, Peter**Address:** 333 Burma Road**City:** Oakland, CA 94607**Report No:** WIR-016954**Date Inspected:** 10-Sep-2010**Project Name:** SAS Superstructure**OSM Arrival Time:** 700**Prime Contractor:** American Bridge/Fluor Enterprises, a JV**OSM Departure Time:** 1900**Contractor:** Zhenhua Port Machinery Company, Ltd (ZPMC), Changxing Island **Location:** Shanghai, China**CWI Name:** Qiu Wen**CWI Present:** Yes No**Inspected CWI report:** Yes No N/A**Rod Oven in Use:** Yes No N/A**Electrode to specification:** Yes No N/A**Weld Procedures Followed:** Yes No N/A**Qualified Welders:** Yes No N/A**Verified Joint Fit-up:** Yes No N/A**Approved Drawings:** Yes No N/A**Approved WPS:** Yes No N/A**Delayed / Cancelled:** Yes No N/A**Bridge No:** 34-0006**Component:** Tower & OBG Components**Summary of Items Observed:**

WELDING INSPECTION REPORT

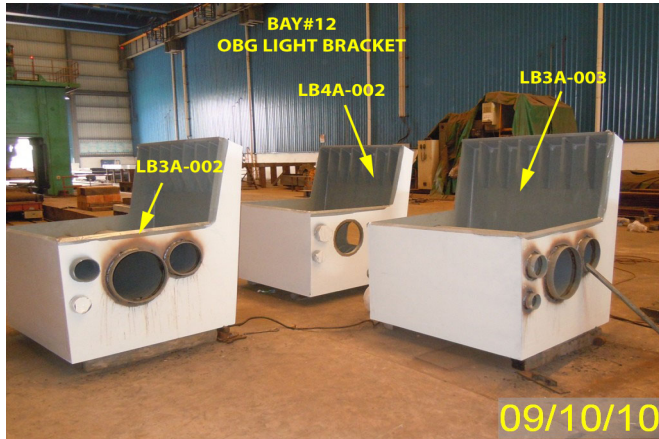
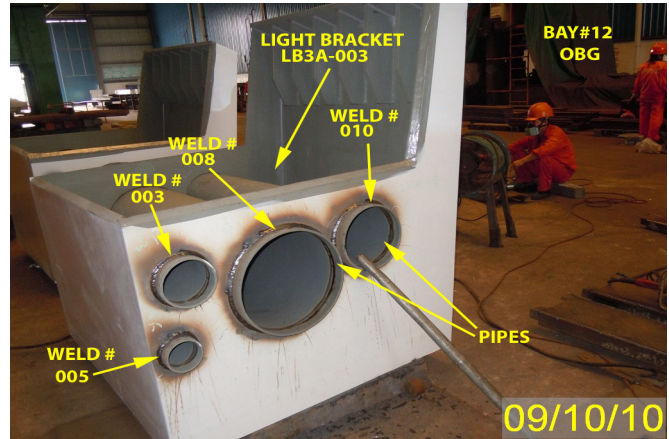
During the Caltrans Quality Assurance (QA) in-process observations of the fabrication of Light Bracket, this QA Inspector discovered the following issues:

-ZPMC personnel performed welding on pipes of 6 Light Brackets using noncompliance combination of WPS's:- WPS-B-T-2132-2 (2F); WPS-B-T-2133 (3F) and WPS-B-T-2134 (4F).

-Fillet weld joining various diameter pipe and side plate of the light bracket.

-The above mentioned WPS's are qualified only for plates.

-The diameter of the pipes ranges from 114 mm to 406 mm.

- 1) LB3A-001, welds#02, 03, 04, 05, 09, 10.
- 2) LB3A-002, welds#02, 03, 04, 05, 07, 08, 09, 10.
- 3) LB3A-003, welds#02, 03, 04, 05, 08, 10.
- 4) LB4A-001, welds#02, 03, 04, 05, 07, 08.
- 5) LB4A-002, welds#02, 03, 04, 05.
- 6) LB4A-003, welds#04, 05.

-AWS D1.1 Table 4.10 - Fillet Weld Option 3

-AWS D1.1 Figure 4.20 - Pipe Fillet Weld Soundness Test - WPS Qualification

-AWS D1.1 (4.11.2) – A fillet welded T-joint, as shown in Figure 4.19 for plate or Figure 4.20 for pipe (Detail A or Detail B), shall be made for each WPS and position to be used in construction.
